Manhole Inspection Summary

Manhole # S09II1007MH

Insp Date: **1/13/09 9:31 AM**

Location Address: **3600 WOODLAND AVE**

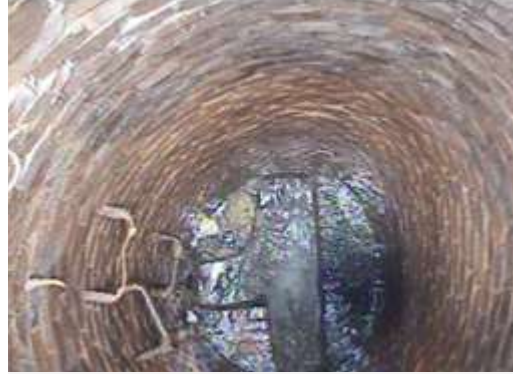
Top View

DEBRIS ON BENCH

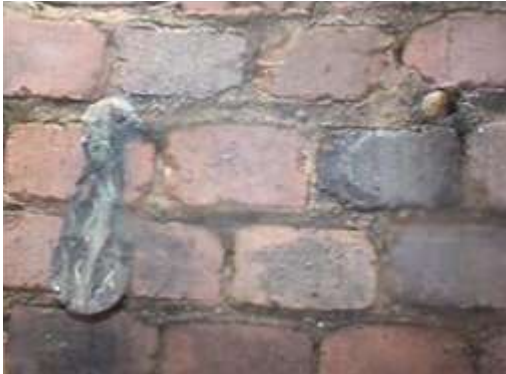
Defect 2

Count: **8** Missing: **1** ☒ **Corroded**

CORRODED RUNG

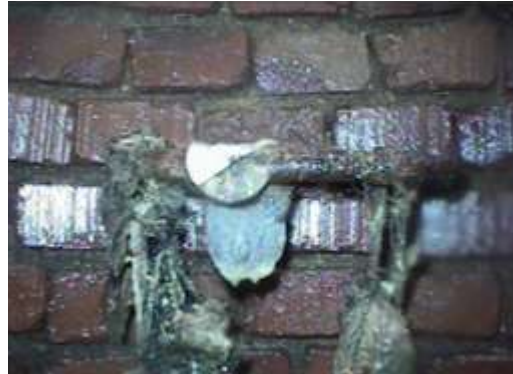
Defect 1

☒ **Evidence Of Surcharge** Depth: **5** (ft.) ☐ Active Surcharge Present

EVIDENCE OF SURCHARGE

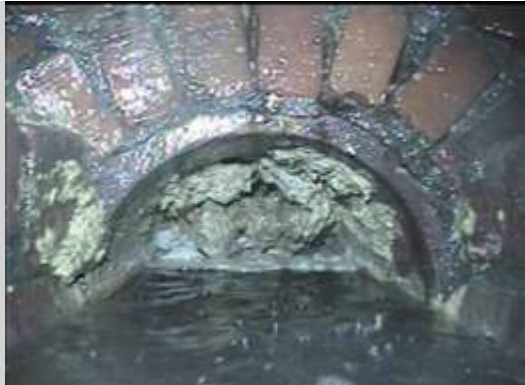
12 O'Clock Outflow

Pipe Height: **8.4** (in.) Rod and Bar
Pipe Material: **Clay** ☐ Pipe Lined
Invert Depth: **14.48** (ft.) Flow Characteristics: **Fast**
Deposits: ☐ None ☐ Mud ☒ Sludge ☒ Debris ☒ Grease
Silt Depth: **6** (in.) Deposits Extent: **Heavy**
Infiltration: **None** Pipe Seal Cond: **Sound**

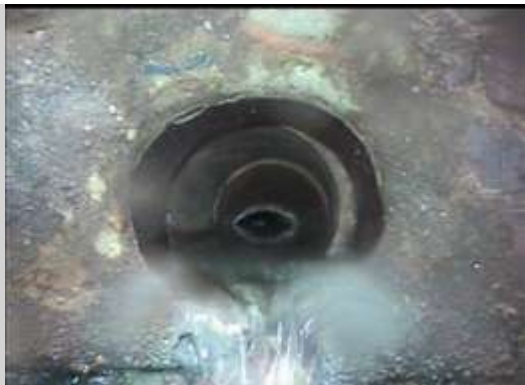
6 O'Clock Inflow

Pipe Height: **4.8** (in.) Rod and Bar
Pipe Material: **Clay** ☐ Pipe Lined
Invert Depth: **7.58** (ft.) Flow Characteristics: **Fast**
Deposits: ☐ None ☐ Mud ☐ Sludge ☒ Debris ☐ Grease
Silt Depth: **3** (in.) Deposits Extent: **Medium**
Infiltration: **None** Pipe Seal Cond: **Sound**

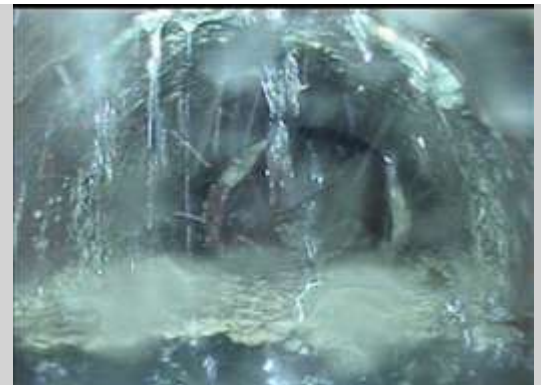
Drop In @ 6 O'Clock

Drop: **Outside** Rod and Bar
Angled: **No** Reading: **14.39** (ft.)
Inv Depth: **14.39** (ft.)
Drop Condition: **Clogged**

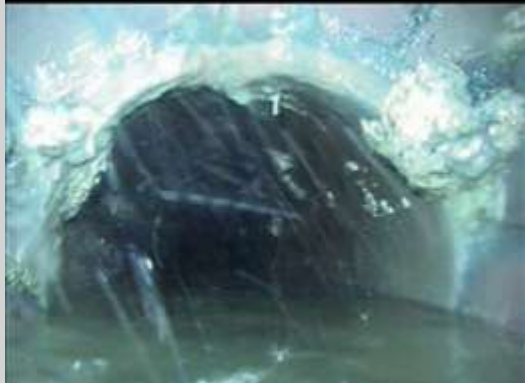
9 O'Clock Inflow

Deposits: ☐ None ☐ Mud ☐ Sludge ☒ **Debris** ☐ Grease

Silt Depth: **3** (in.) Deposits Extent: **Medium**
